Application of G100/120 Thermal Imaging Camera in Energy Efficiency Measuring in Building Construction

Aleksandra Pavlović¹, Žarko Barbarić¹

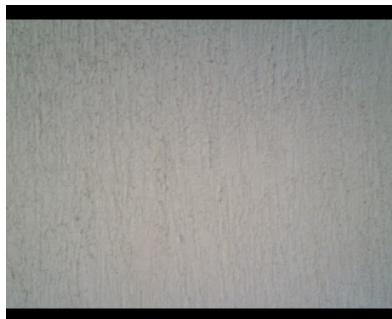
Fig. 3 – Outer surface of the wall (visual image).

Temperature and emissivity of the walls were assessed using thermal imaging camera. Figs. 2 and 3 give the inner and outer surfaces of the building wall in the visible range. Figs. 4 and 5 give the same surface of the walls, in the infrared domain.

In order to verify the results of temperature measurement with thermal imaging camera, contact thermometer with a probe was used. It was measured the temperature of an object that represents approximately black body (black bag) and the measured value was 28°C. By using the thermal imaging camera function for emissivity correction, emissivity of the measured object was reduced until its temperature was equalized with the temperature of the blackbody. In this way, the emissivity of the walls was measured, and the results were as follows: the emissivity surface of the inner wall was 0.65, while the emissivity of the outer wall surface was 0.74. By using contact thermometer the temperature of the inner and outer walls was measured, and the following values were obtained: the temperature of the inner wall was 26°C and the temperature of the outer wall was 27°C. Temperature of the walls was measured using the thermal imaging camera (after adjusted measured emissivity) and the results were as follows: the temperature of the inner wall was 25.6°C and the temperature of the outer wall was 26.5°C.

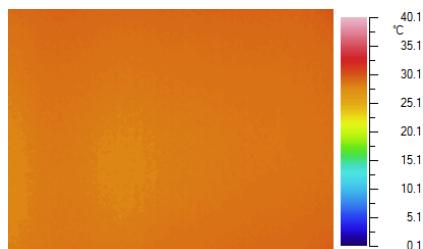
**Fig. 5 – Outer surface of the wal
(thermovision image).**

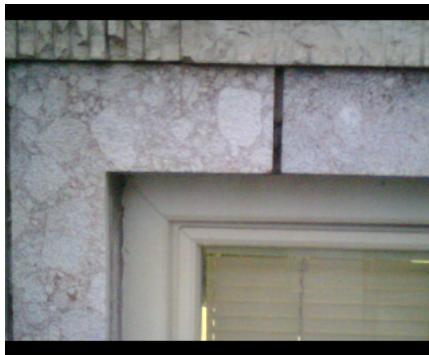
Fig. 6 – Poorly built and installed windows and insulation problem (visual image).

In Fig. 6 the voids can be seen between the wall parts of the set of elements (plates), filled with mortar. As for the window, we do not observe any defects.

The first image shows a part of a window in a masonry building. Fig. 6 shows a visual image of the window [8].

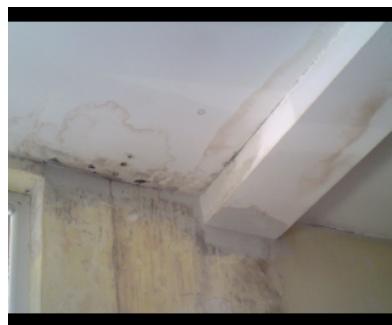
Fig. 9 – The infiltration of water and moisture problem (visual image).

In Fig. 9 we observed field of yellow and black spots. Also, the changes in color have been observed, and both mechanical damage caused by moisture.

Another pair of images is relating to the building's interior, having moisture on the walls. Fig. 9 shows the television image of the wall and the ceiling [8].
